# **Parcel C Remedial Action Project Update for Parcel C Hunters Point Naval Shipyard San Francisco, California**

Tony Konzen  
Project Manager  
Contracted Support to NAVFAC BRAC PMO

BCT Meeting February 27, 2014

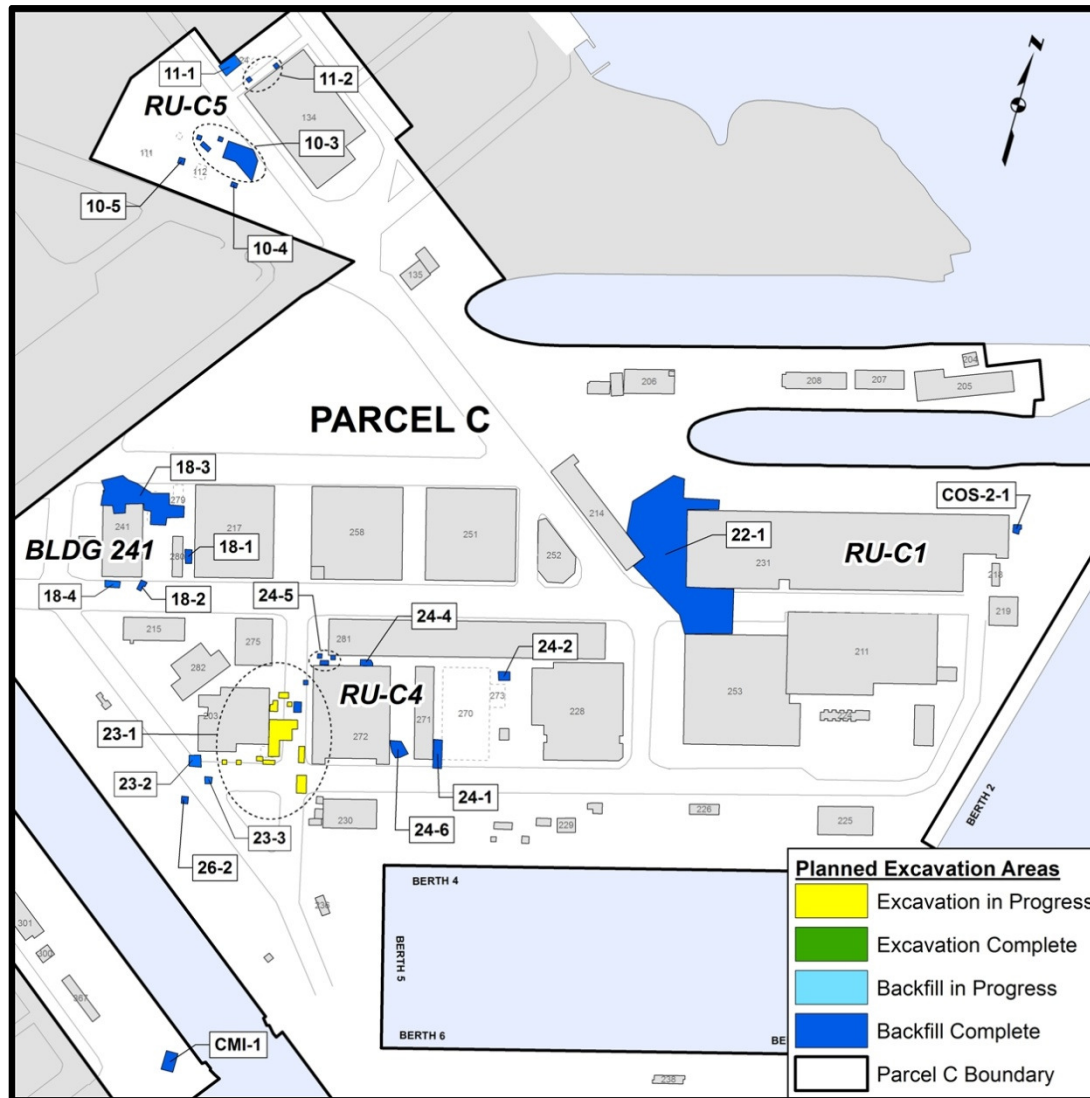
# Parcel C Excavation Status

- Approximately 25,720 bcy have been excavated (February 13, 2014).
- Data for one confirmation sample is pending before 23-1 is complete (see Figure).

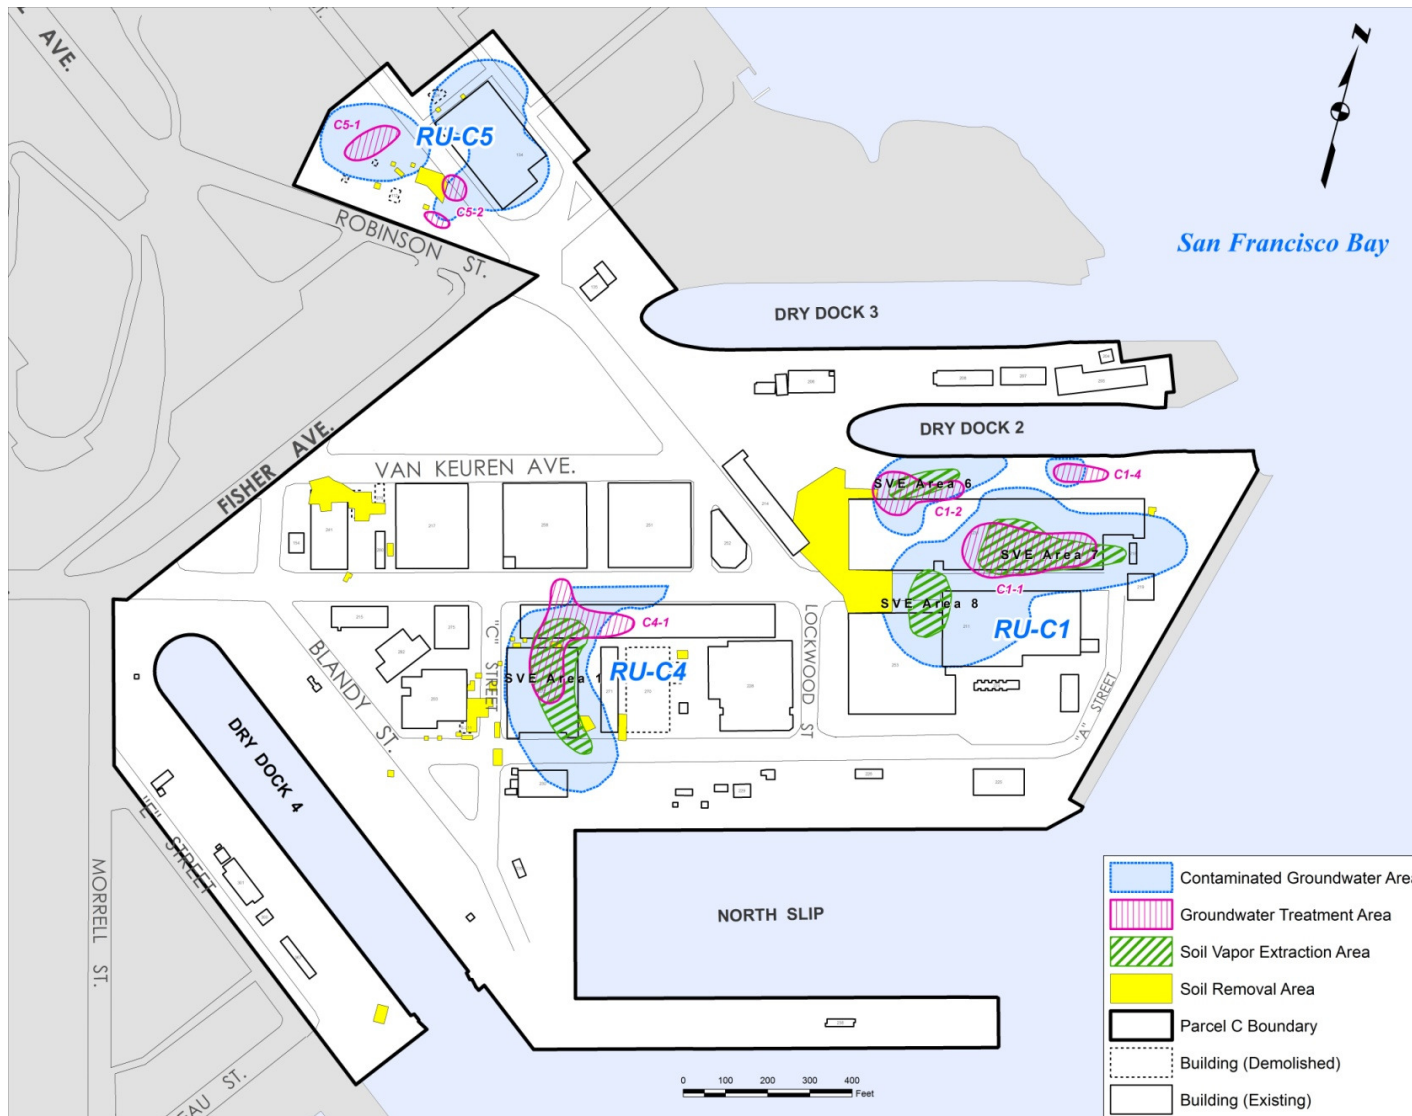
## Parcel C Injection Locations and SVE System Locations

Parcel C Remedial Action  
Plumes to be treated by  
CB&I:

- Plume C1-1
- Plume C1-2
- Plume C1-4
- Plume C4-1
- Plume C5-1
- Plume C5-2

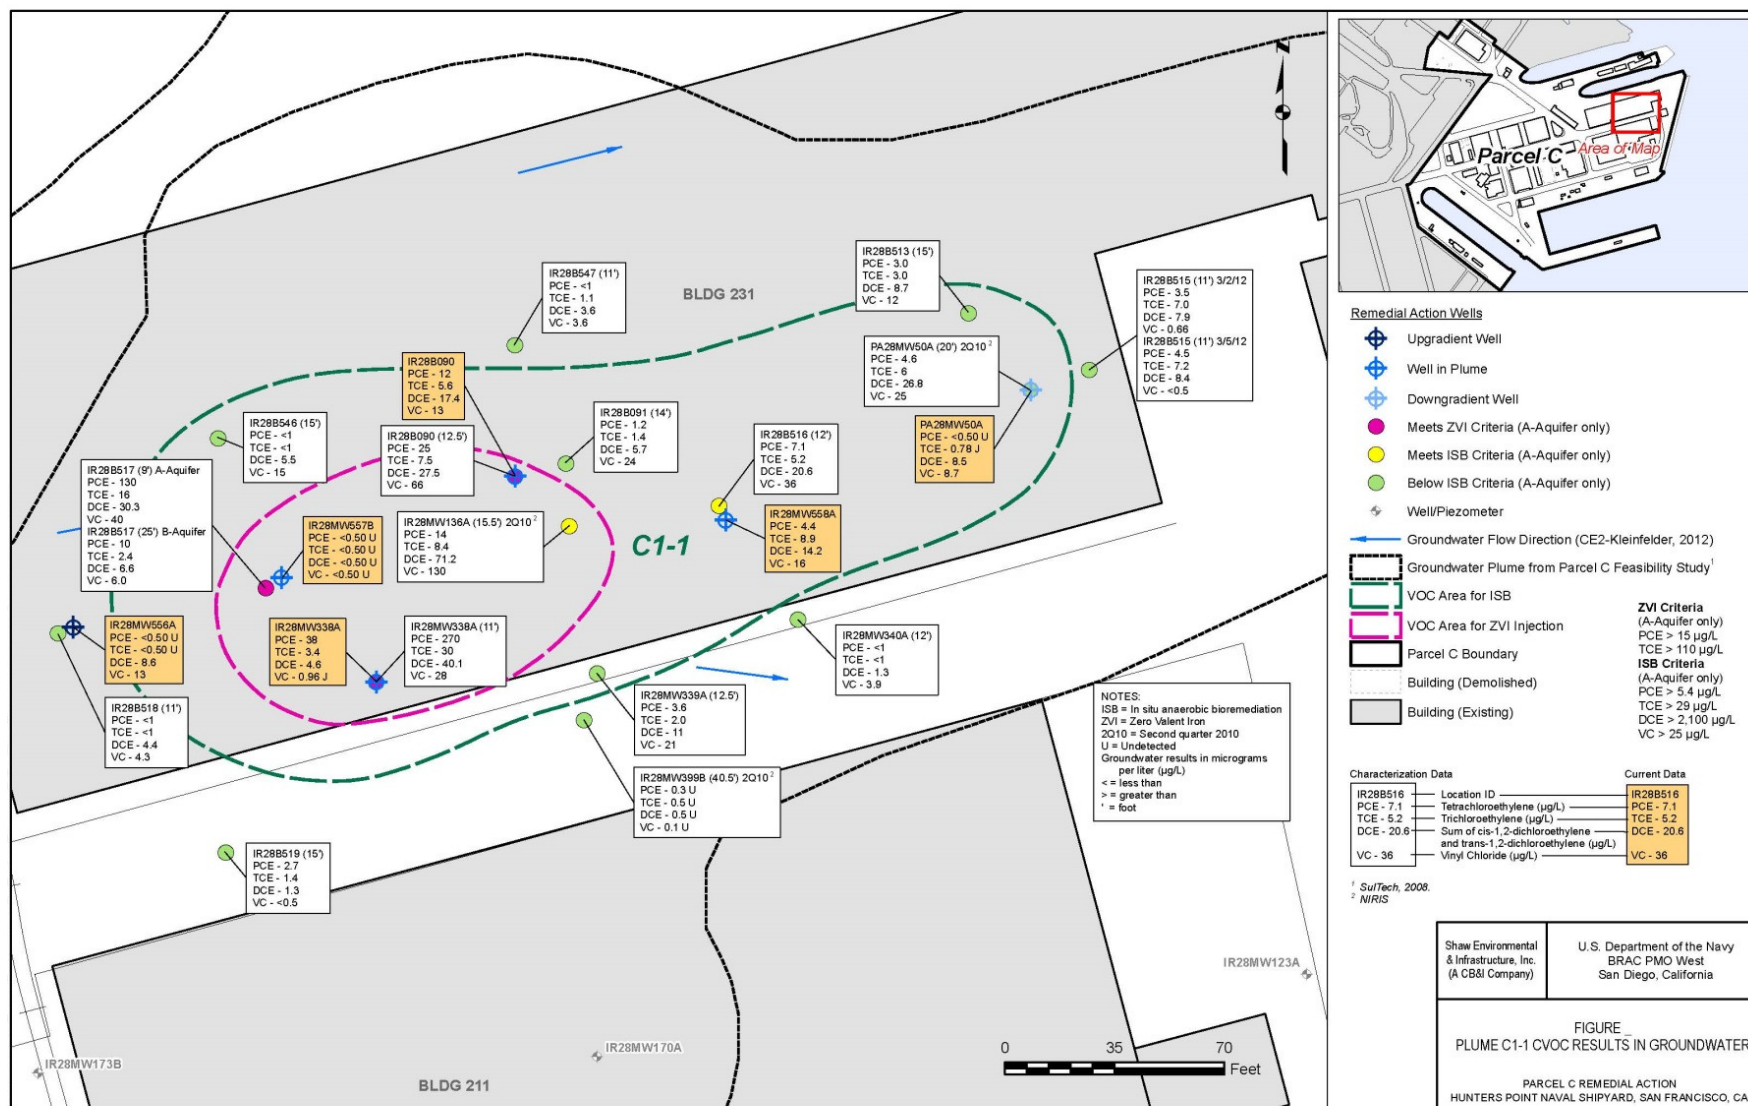
## 2013 Baseline Groundwater Sampling Results

# RU-C1 Plume C1-1

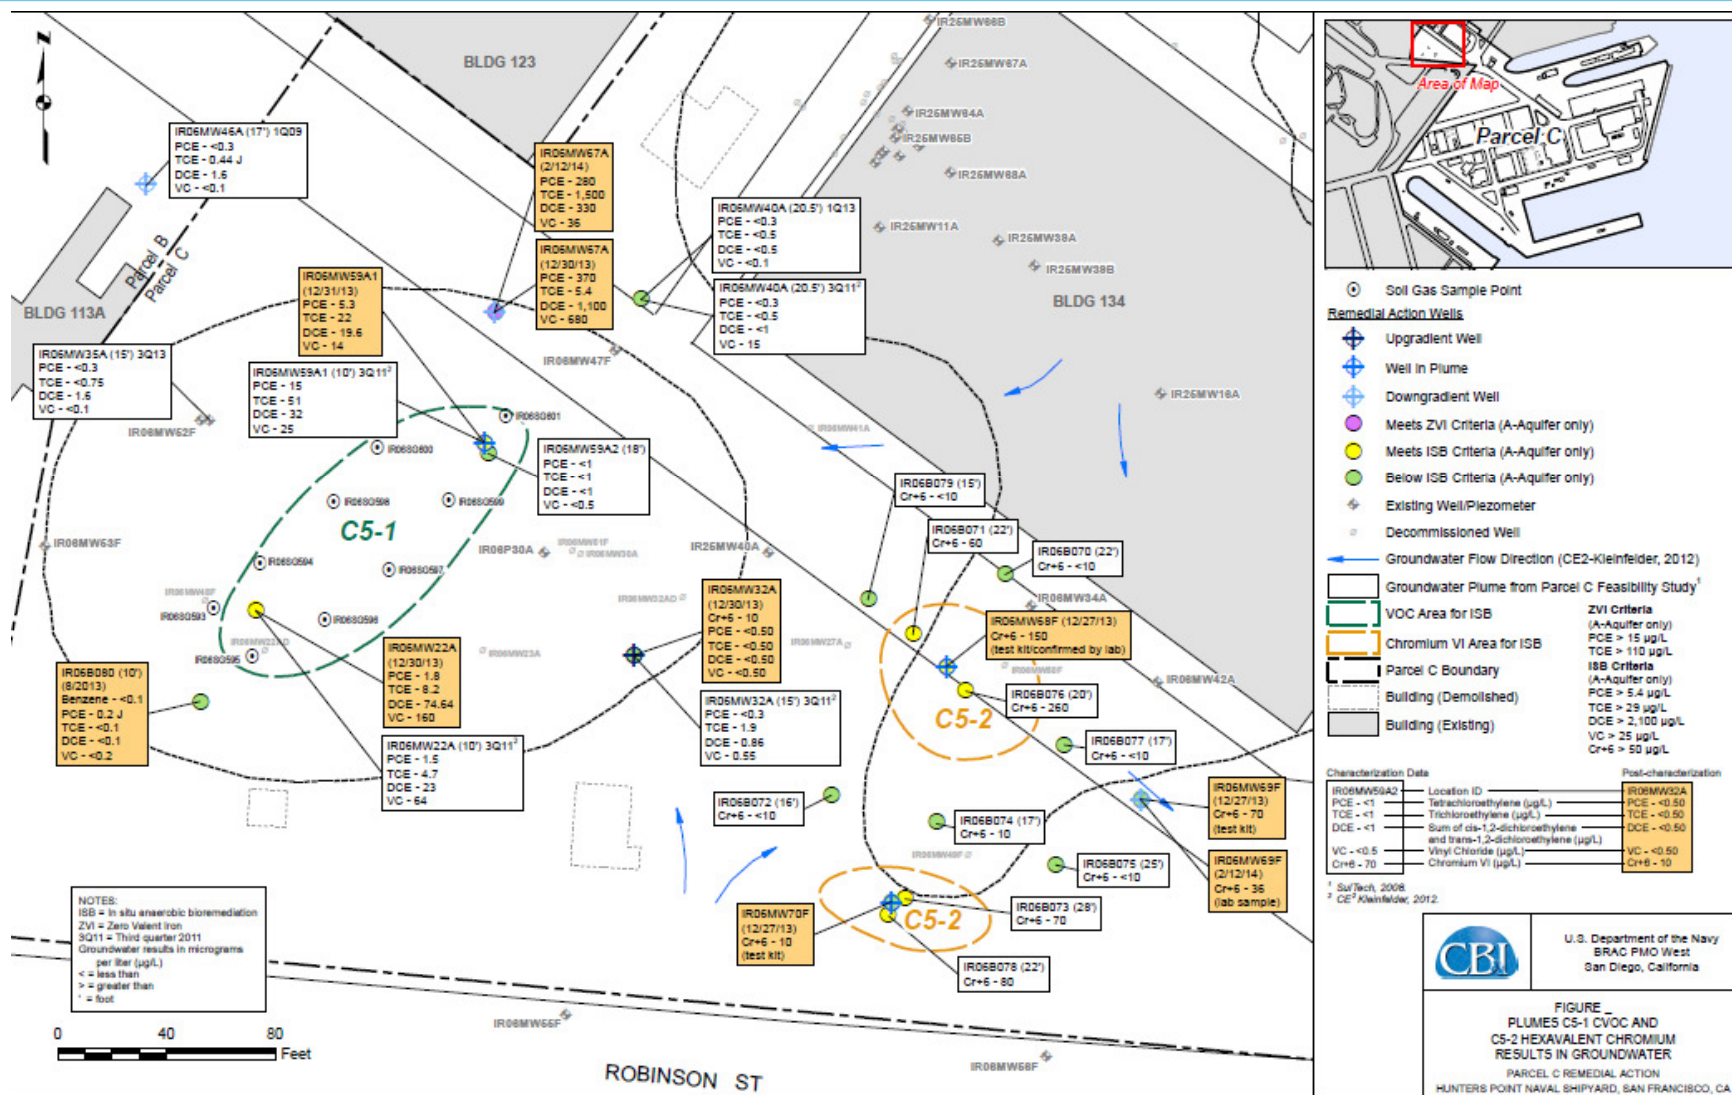
# RU-C5 Plumes C5-1 and C5-2 2014 Baseline Sampling and Re-Sampling Results

- Groundwater monitoring well IR06MW67A was sampled to verify the plume location as part of the Dec 2013 baseline sampling prior to commencement of ISB injections.
- IR06MW67A was previously located outside the known plume, but now showed VOC levels (TCE, PCE, DCE, vinyl chloride) above ISB treatment criteria.
- Re-sampling of the well in February 2014 confirmed the VOC results.

**Recommendation:** Further characterization to bound the RU-C5 plume in Spring 2014. Based on GW results, further bioremediation may be required.

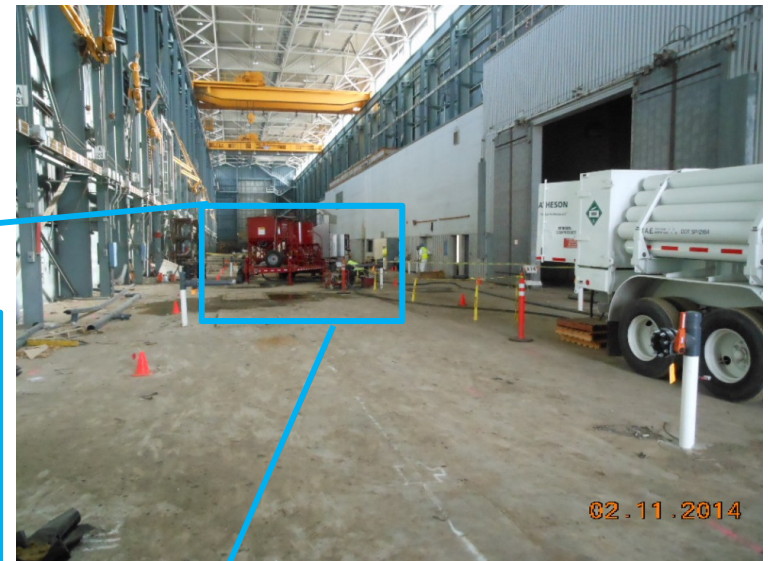
Nitrogen Tube Trailer

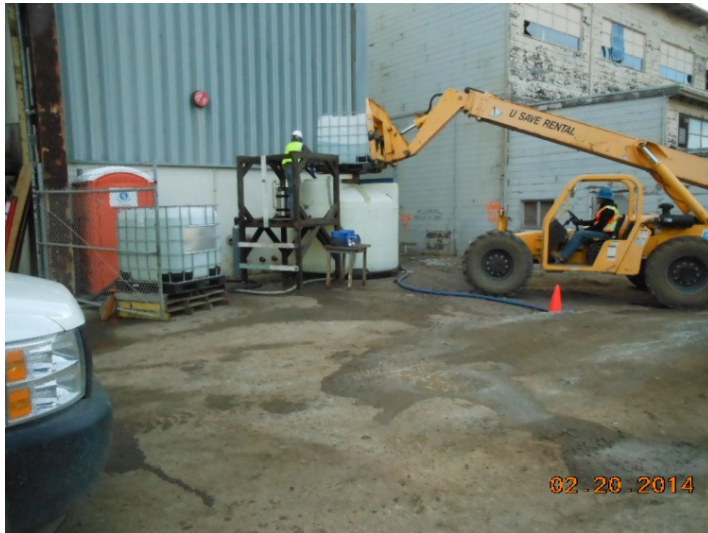
Adding Water from Frac Tank and Lactate to Batch Tank

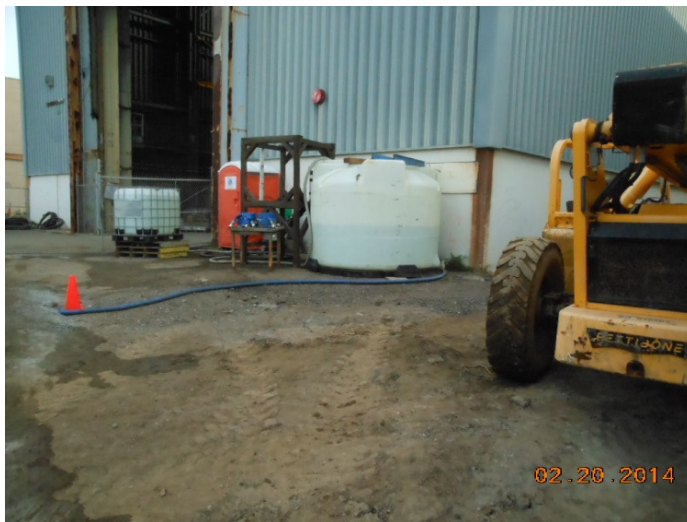
Mixing Water/Lactate with  
SDC-9 in Batch Tank

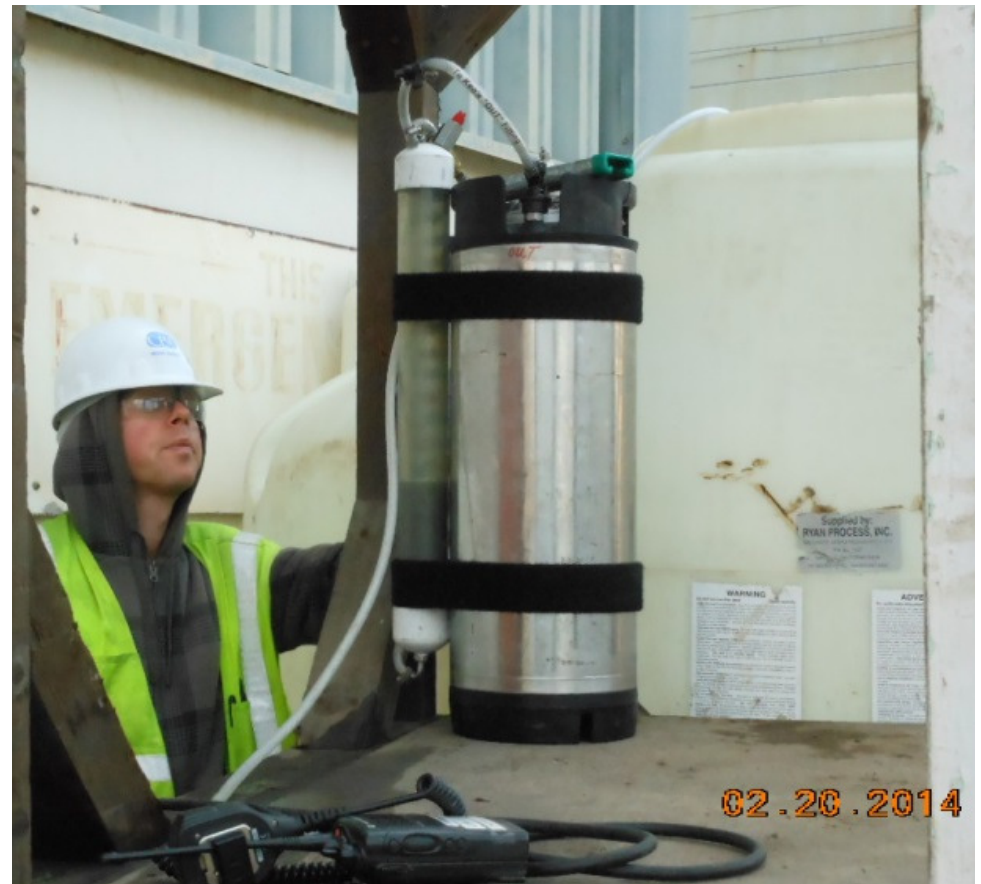
Adding SDC-9 to Batch Tank

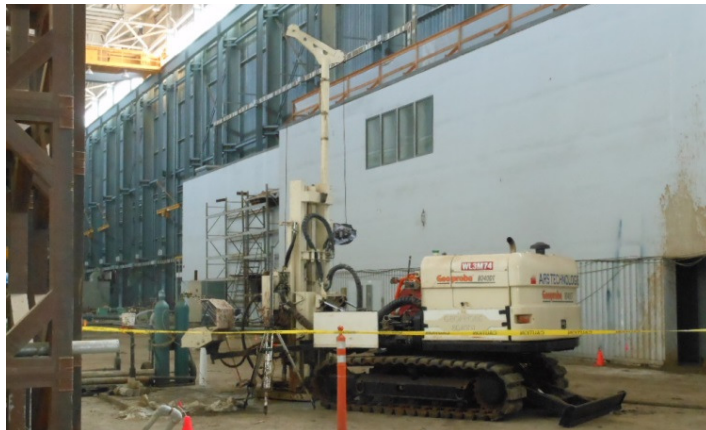
Drill Rig with Packers Set in Boring

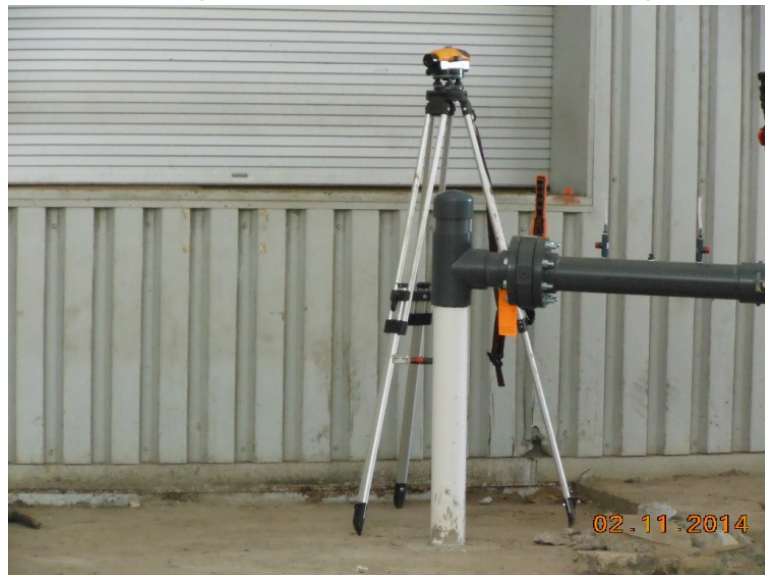
Floor Level Monitoring No Floor Deformation

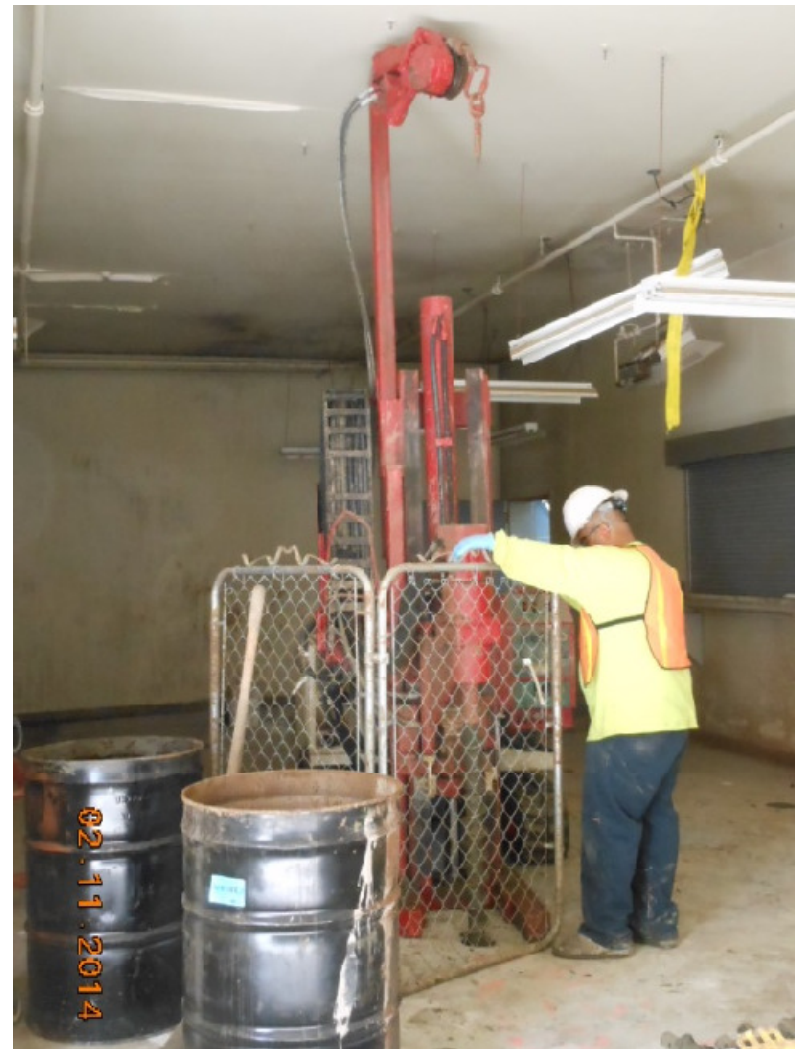
Drilling Injection Boring

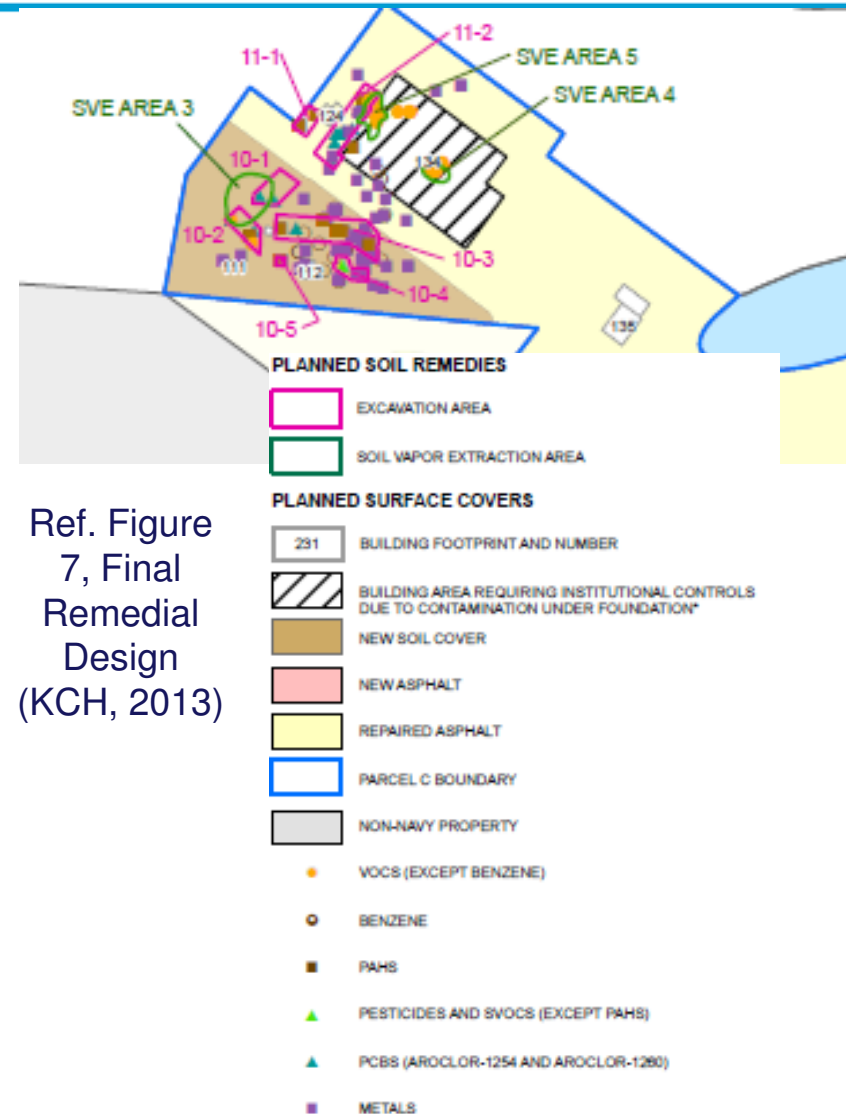
## RU-C5: SVE Areas 4 & 5

- SVE Areas 4 & 5 from the Remedial Design are located within Bldg. 134.
- SVE Areas 4 & 5 were not included in current project scopes pending results of Treatability Study (CDM Smith 2012).
- The Treatability Study was effective in reducing VOCs in groundwater and soil vapors but did not eliminate the need for installation of SVE Systems in Area 4 & 5.
- VOC levels in soil vapor at Bldg. 134 remain above Soil Gas Action Levels (SGALs) after the Treatability Study.
- Most recent BWGM Exceedance Memo (September 2013) indicates VOC levels in groundwater remain above RGs.

**Recommendation:** Further characterization in Spring 2014. Based on GW results, further bioremediation may be required too.

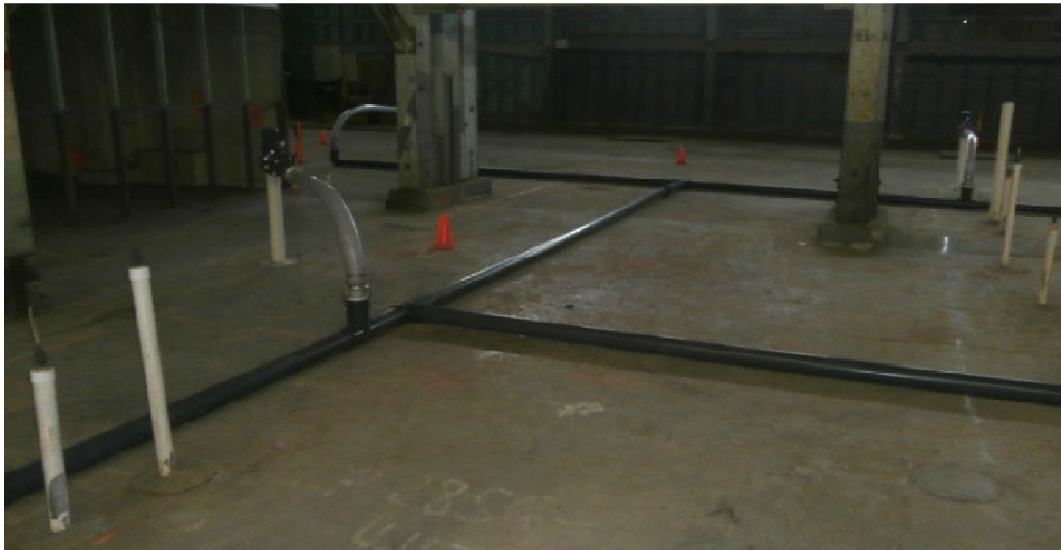
SVE Area 1 System at  
Building 272 and 281

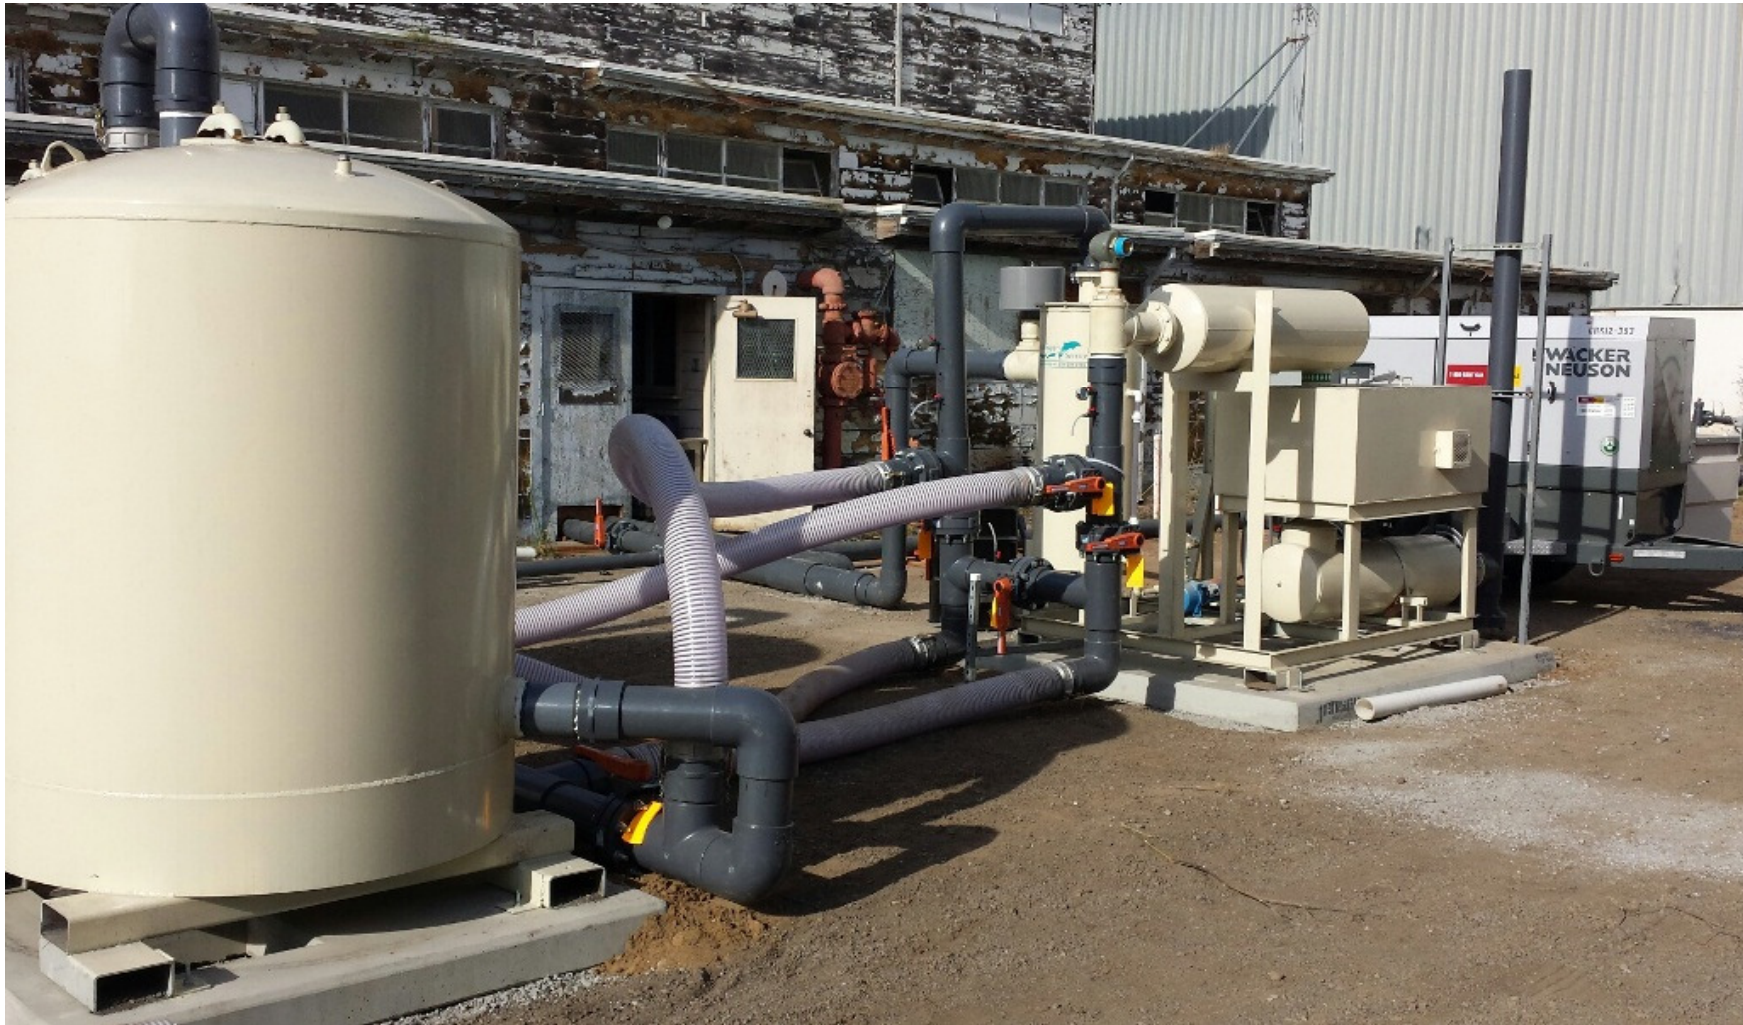
### Start Up of SVE Area 1 System Outside Building 272 (RU-C4)

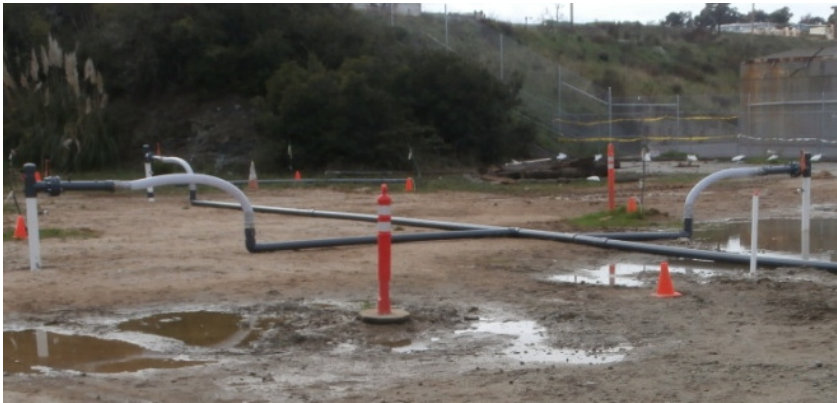
Layout of SVE Area 3 (RU-C5)

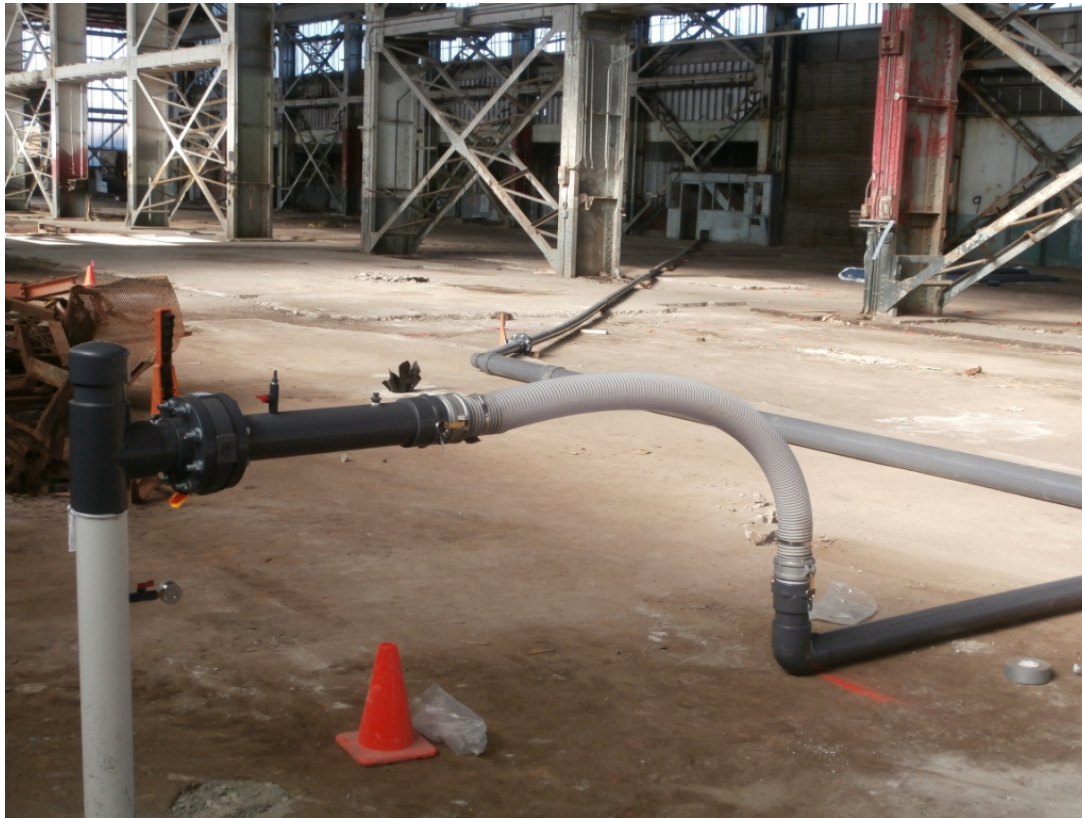
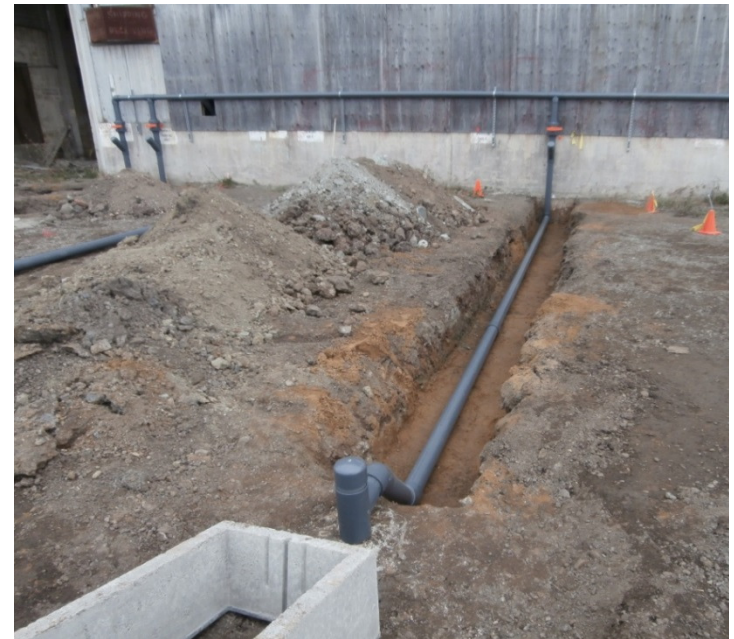
## Sections of SVE System in Area 6 and 7 (RU-C1)
